## Brake Rotor Installation Tips

**To assure pulsation free performance over the life of your brakes**

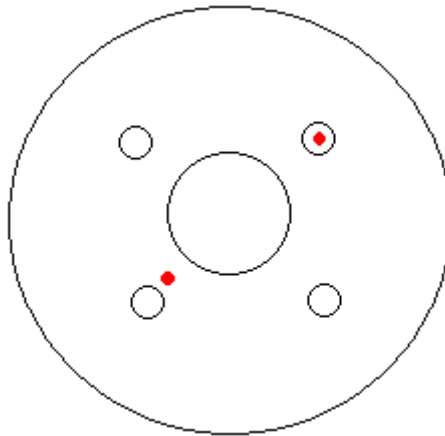
- Next, remove the rotor and install in a different position on the hub:

Measure runout and record results once again. If the results from both measurements match in both location and amount of runout measured, then excessive runout exists in the rotor itself, and the rotor requires either replacement or machining.

- If the results from both tests are marked in different locations on the rotor, then runout exists in the hub. If this is the case, cleanliness of mating surfaces should be confirmed once again, and then hub runout measured to confirm previous results. Any measurable hub runout requires hub replacement or a more short term solution of machining the disc on the hub using an on-car lathe. An on-car lathe will yield a finished product that compensates for any hub runout and if done correctly, will result in a rotor with ZERO installed runout when mounted to the hub in the same position in which it was machined. Any hub runout will show up as a considerably higher number when measured at the edge of the rotor....the larger the rotor, the greater the increase in measured runout.
