Brake Rotor Installation Tips

To assure pulsation free performance over the life of your brakes

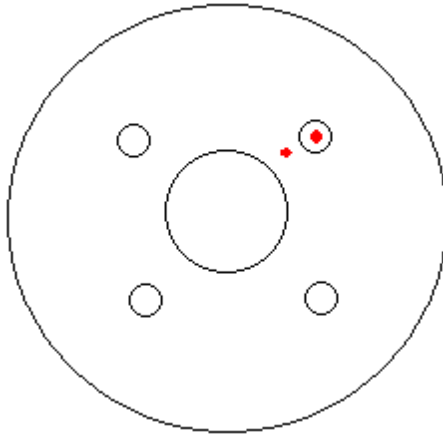
- Confirm that the hub and rotor mating surfaces are clean and free of any rust, dust, or other debris, install the rotor onto the hub, and mark the initial position with a paint mark on a lug stud and next to the corresponding lug hole.

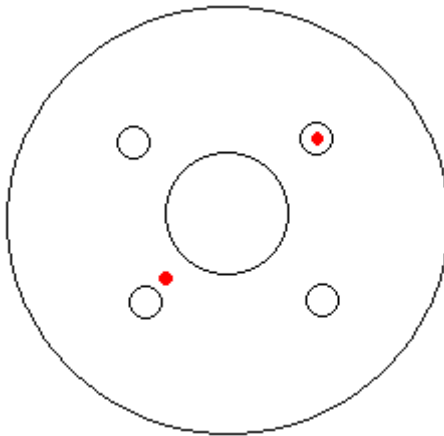
- Next, remove the rotor and install in a different position on the hub:

Measure runout and record results once again. If the results from both measurements match in both location and amount of runout measured, then excessive runout exists in the rotor itself, and the rotor requires either replacement or machining.

- If the results from both tests are marked in different locations on the rotor, then runout exists in the hub. If this is the case, cleanliness of mating surfaces should be confirmed once again, and then hub runout measured to confirm previous results. Any measurable hub runout requires hub replacement or a more short term solution of machining the disc on the hub using an on-car lathe. An on-car lathe will yield a finished product that compensates for any hub runout and if done correctly, will result in a rotor with ZERO installed runout when mounted to the hub in the same position in which it was machined. Any hub runout will show up as a considerably higher number when measured at the edge of the rotor....the larger the rotor, the greater the increase in measured runout.
